**Re: Willsmere Estate, 1 Wiltshire Drive, Kew.**

As requested, I have undertaken an inspection of four mature trees located within the subject site 1 Wiltshire Drive, Kew, with a view to determine the health, structure and condition, and provide recommendations as to the future management of the same. Please find herewith my findings and recommendations.

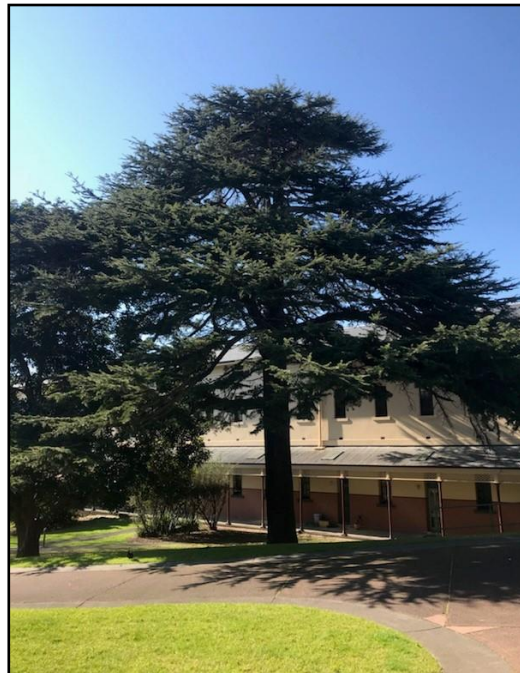
Figure 1. Overall structure of Tree 1.

The tree presents as a significant specimen and adds much value to the property and surrounding landscape, it represents a tree of good health, with good structure and condition, with a DBH of 1115mm and an approximate height of 18m.

The tree represents as an attractive tree with a well-balanced canopy, there are no visible faults or structural issues which can be observed through a ground-based inspection, however there does exist minor deadwood to approximately 30mm diameter which is typical for a tree of this species and age, however does not constitute significant health or safety issues.

Several steel cables have been previously installed in the upper canopy, to brace and support the weight of these large limbs, allowing them to share the load of the canopy instead of supporting the entire weight alone.

Several previous limb failures were observed within the North-Eastern canopy, with evidence of this in the upper canopy.

It is recommended that the tree undergo a thorough aerial inspection, at which time remedial pruning works can be undertaken which would remove all deadwood greater than 25mm, weight reduction of the extended lateral limbs growing over the footpath and lawn area and inspect the cables that are installed in the upper canopy.

It is also recommended that the tree and the steel cables installed within the canopy of this tree, be inspected and assessed annually for structural integrity and any signs of degradation.

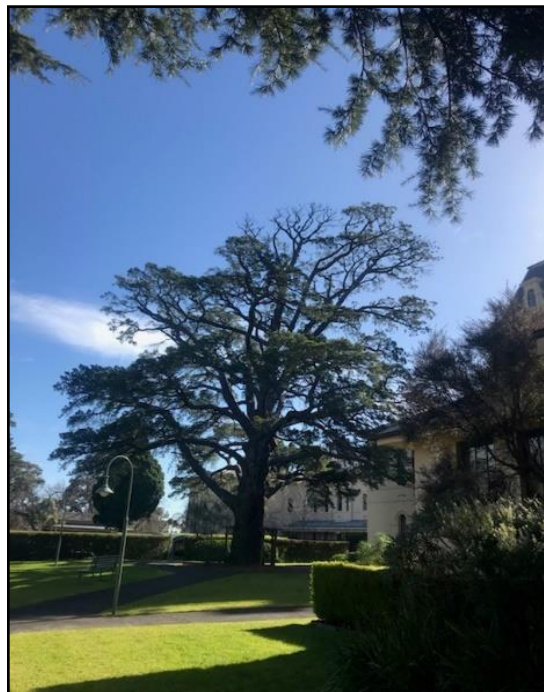
Figure 2. Overall Structure of Tree 2.

The tree presents as a significant specimen and adds much value to the property and surrounding landscape. The tree is true to type and represents fair health, with fair structure and condition, with the a DBH of 1398mm and an approximate height of 20m.

The tree has developed with co-dominant stems and presents with several unfavorable attachments with included bark and heavy lateral limbs throughout the canopy. There have been approximately 10 steel cables previously installed in the upper canopy, to brace and support the weight of these large limbs, allowing them to share the load of the canopy instead of supporting the entire weight alone.

The dominant stem appears to be in decline, with evidence of dieback and excessive deadwood throughout the upper canopy. Previous minor failures were observed throughout the upper canopy and deadwood to approximately 50mm diameter, which is typical for a tree of this species and age.

It is recommended that the tree undergo a thorough aerial inspection, at which time remedial pruning works can be undertaken which would remove all deadwood greater than 25mm, and weight reduction of the extended lateral limbs growing over the footpath and grassed area.

It is also recommended the main stem in the upper canopy, that appears in decline, be removed. That the steel cables installed within the canopy of this tree should also be inspected and assessed annually for structural integrity and any signs of degradation.

This tree must be monitored regularly and inspected by a qualified arborist on an annual basis.

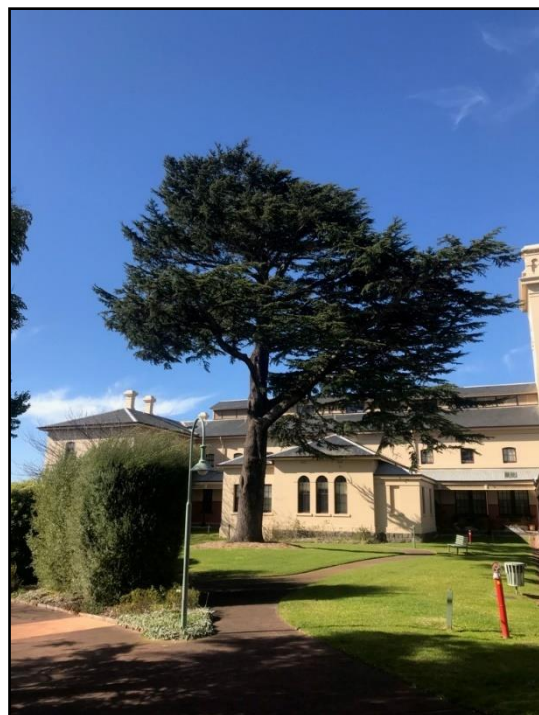
Figure 3. Overall structure of Tree 3.

The tree presents as a significant specimen and adds much value to the property and surrounding landscape, it represents a tree of good health, with fair structure and condition, with a DBH of 1178mm and an approximate height of 18m.

The tree presents with a co-dominant, extended lateral limb growing to the East. Previous minor failures were observed throughout the upper canopy and deadwood to approximately 50mm diameter, which is typical for a tree of this species and age.

It is recommended that the tree undergo a thorough aerial inspection, at which time remedial pruning works can be undertaken which would remove all deadwood greater than 25mm, weight reduction of the extended lateral limb growing to the East over the footpath and lawn area and inspect the cables that are installed in the upper canopy.

It is also recommended that the tree and the steel cables installed within the canopy of this tree, be inspected and assessed annually for structural integrity and any signs of degradation.

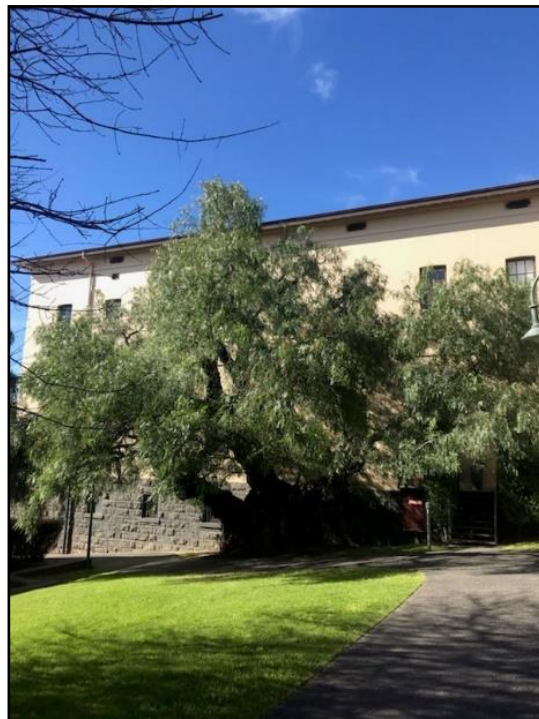
Figure 4. Overall Structure of Tree 4.

The tree presents as a significant specimen and adds much value to the property and surrounding landscape. The tree represents fair health, with poor structure and condition, with the a DBH of 2550mm and an approximate height of 10m.

The canopy consists of three major scaffold limbs, growing to the South-West, to the West overhanging the pathway, and to the North towards the nearby units, with a dominant leader located centrally within the canopy.

There are currently three cables within the tree canopy, one of which is attached to the South-Western limb, the other two are attached to the Western stem overhanging the footpath. All cables are attached to the main upright stem within the middle of the canopy as the main support. There is substantial tension within the cables, suggesting a reliance on them for structural stability and support.

The branch growing to the West, overhangs the nearby footpath which provides access for pedestrians to the rear car park area.

This major limb is attached to the main stem, adjacent to the active split and associated decay present within this union. This has resulted in a poor attachment to the main trunk, with cabling works having been undertaken in an attempt to reduce the risk of total limb failure. This branch also represents an over extended and heavy ended lateral branch.

Upon investigation the cable attached to the limb was discovered to be under substantial tension, suggesting a reliance on this for structural stability and support. A wound from a

recent failure was observed in the upper canopy of this limb as well as decay from previous branch failures.

The other major scaffold limb growing to the North, overhanging the nearby footpath and extending towards adjacent residences, is considered to be in the best condition, both structurally, and from a tree health perspective. It is attached to relatively sound wood within the main trunk, however is still considered to require weight reduction works to reduce the effects of leverage on the main attachment.

In order to reduce the risks associated with this branch attachment, severe weight reduction works, and cable repositioning must be undertaken.

Thorough weight reduction works and the use of appropriately positioned cables can reduce this risk, with constant monitoring by garden staff and regular inspections made by a qualified arborist to determine any further changes to structural integrity.

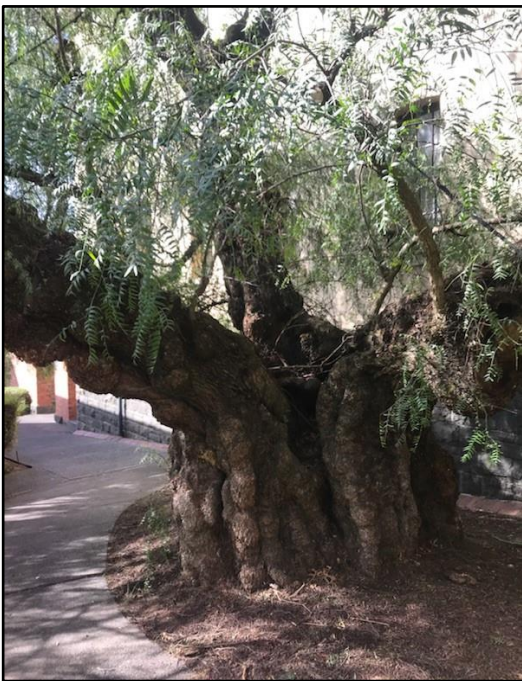
The limb growing to the South-West represents a relatively lateral branch, with a heavily weighted end. The attachment of this branch to the main stem is structurally flawed with an active split present, which extends entirely to ground level. (Refer to Figure 4)

*Figure 5. Active split and associated decay.*

Upon inspection of this attachment, it was discovered that the cable is supporting the majority of the branch weight, with moving and twisting of the branch able to be achieved through manual manipulation.

The split which is present can be viewed from both sides of the trunk, confirming that the split is active, with the potential for total failure at this point. Extensive decay is also present within this area, further weakening the branch attachment and increasing the likelihood of failure. This branch is being supported by the previously installed cable which is putting excessive pressure on the attachment within the upper main trunk.

In order to reduce the risks associated with this branch, severe weight reduction works, and cable repositioning must be undertaken. These works will include the reduction of the branch back to the next major upright section, approximately 1m away from the main stem, with the cable also being moved beyond this point.
