Annual Heritage Report 2021

Former Willsmere Asylum, Kew

Author Priyan Perera and Mark Stephenson
Trethowan Architecture
Date 25th February 2022

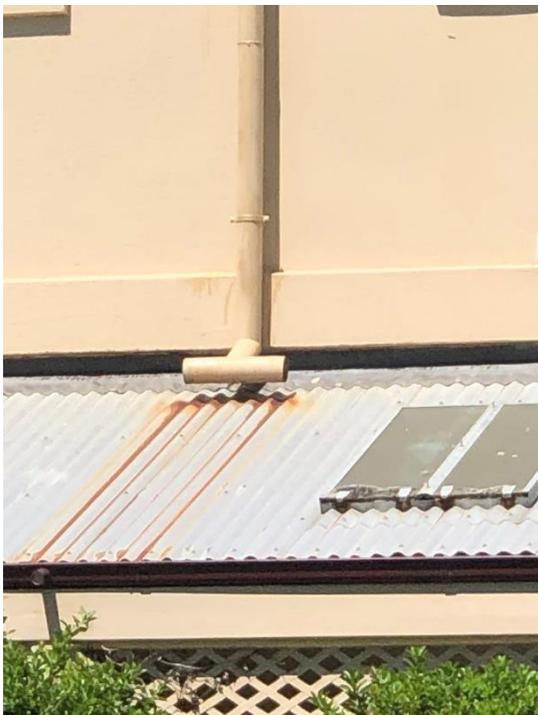
There is typically staining to all verandah roofs where downpipes from the roof above discharge. There are many factors that could lead to this occurring. Incompatibly of metals between the gutters, downpipes and roofs leading to increased corrosion of either one of those elements. It could also be caused by secretion of tannins from leaves & debris that have accumulated in gutters and downpipes, in which case the staining would likely be superficial only.

Figure 2 – Typical Staining to verandah roofs found at the base of downpipe spreaders from roofs above.

Recommendation: Further investigation will be required to establish the root cause of staining. Firstly, up-close analysis will be needed to determine if it is actual rusting of the roof sheet or superficial staining.

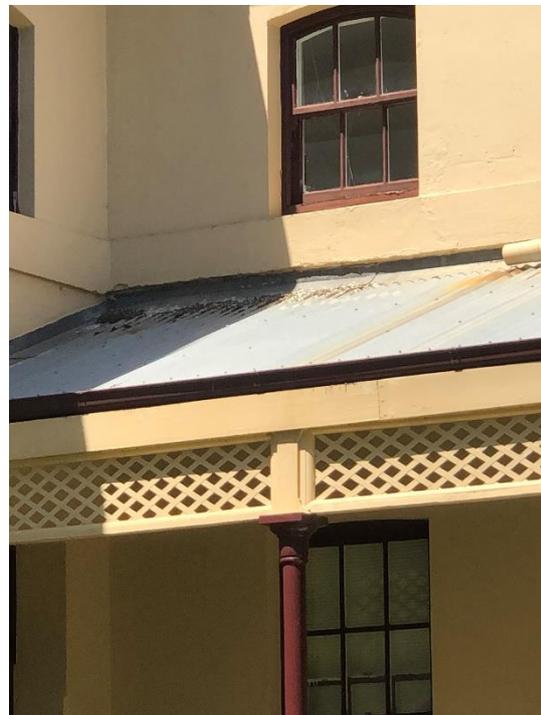
Figure 3 – Bird fouling to West verandah roof outside unit 19 (Central wing)

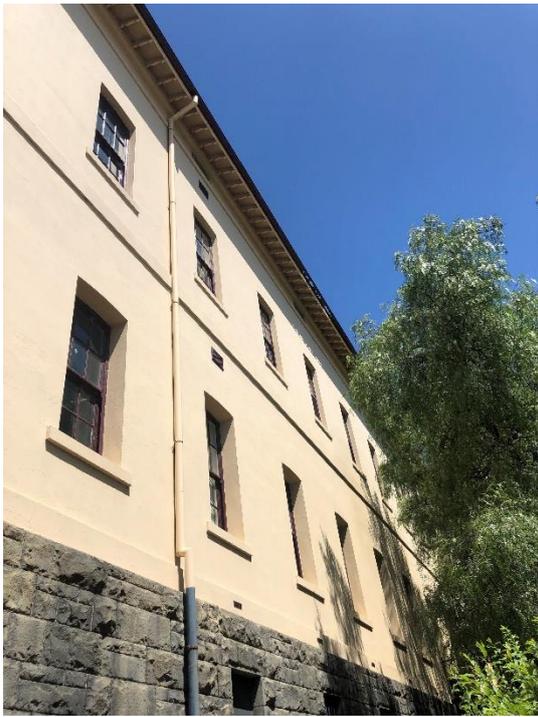
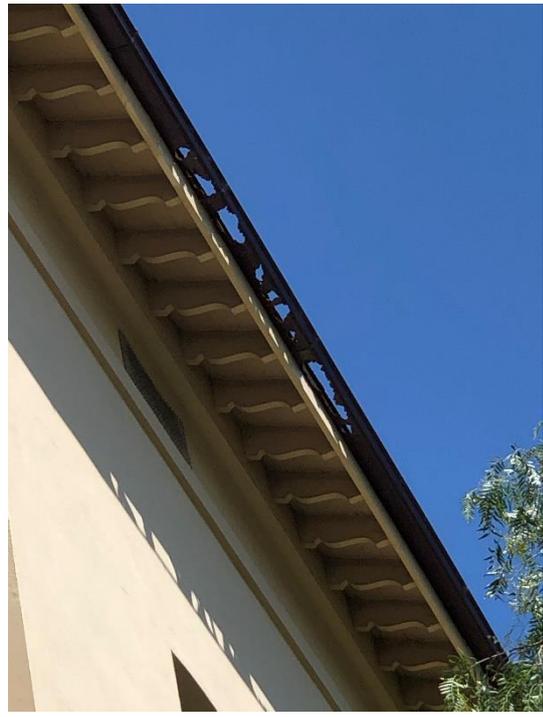
Generally, gutters remain in good condition with the exception being the Northern end of the Northeast Wing, where the gutter has severely corroded to the point of complete failure.

It is unlikely this is due to build-up of debris given the height difference to natural ground level however, given the close-proximity of the downpipe, it could be caused by insufficient fall / slump leading to water pooling.

Figure 4 - Severely corroded gutter to North side of unit 135

Recommendation: Replacement of failed gutters and downpipes on the Northeast wing. Further investigation of the roof in this area also is highly recommended to determine what has caused this rapid decay to surrounding rainwater goods.

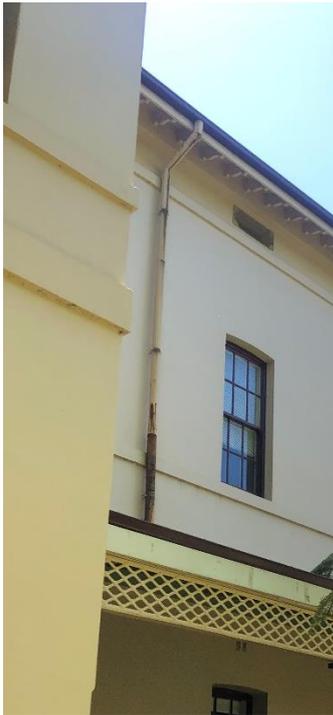
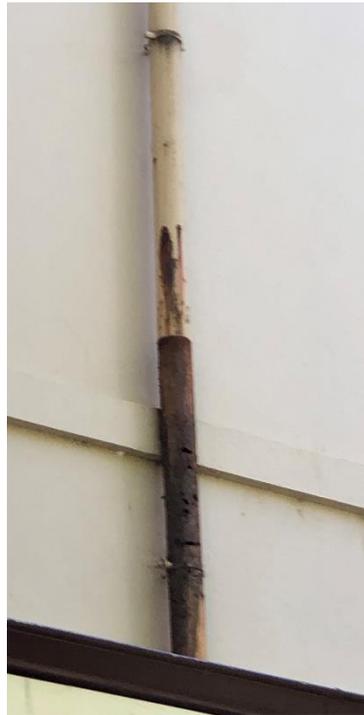
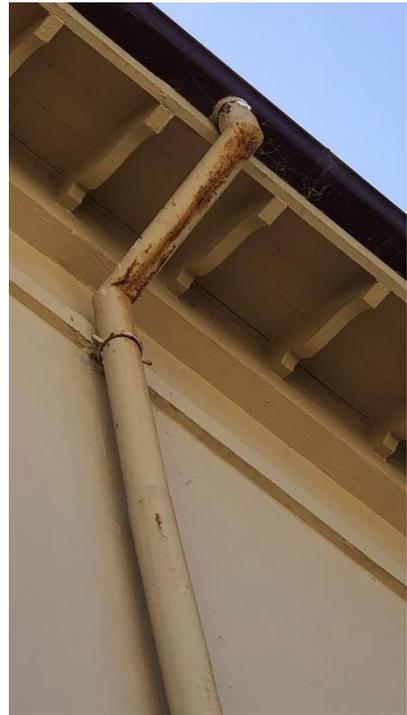
It may be a coincidence that the downpipe on the other side of this wing – See figure 5 (both sides of unit 135) - has also deteriorated excessively, however there is a potential that there is a reactive material on the roof in this area that is contaminating the rainwater.

Figure 5 – Downpipe located on east side of unit 135 showing heavy corrosion and detachment from gutter.

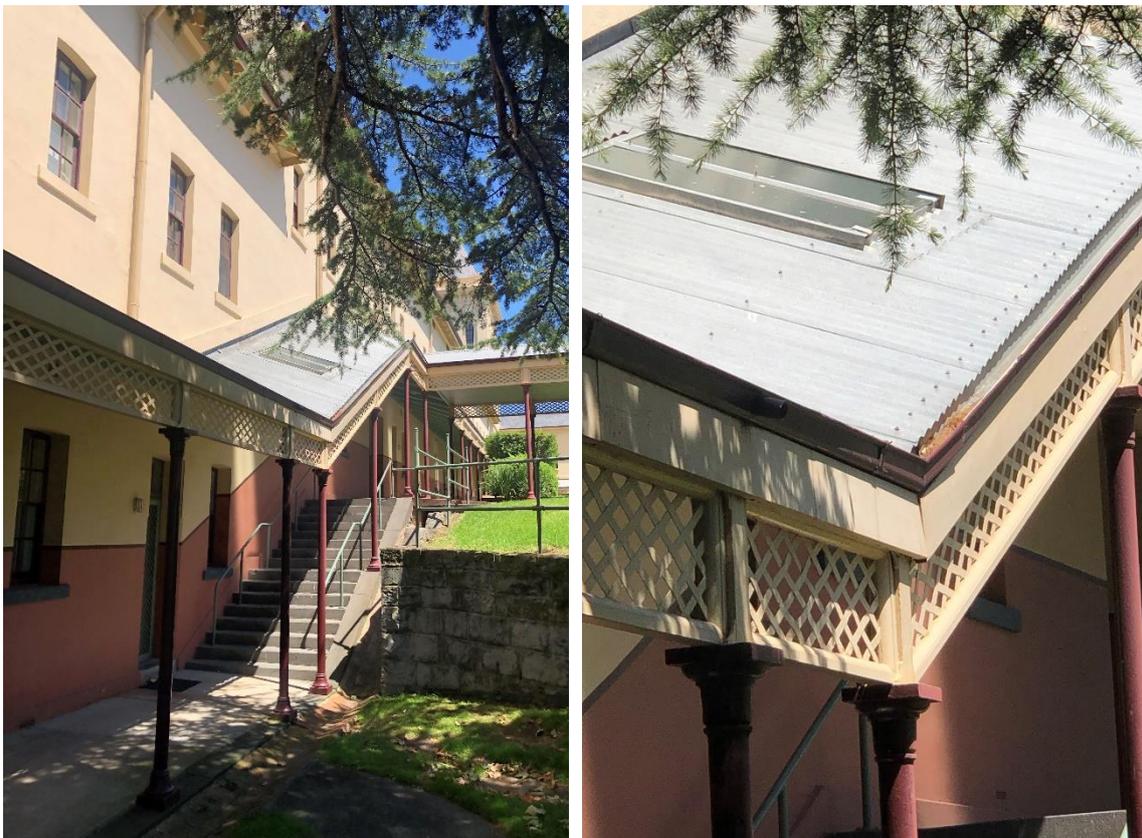
Given the proximity of trees to majority of verandah gutters, in some cases being completely overshadowed it is likely leaf build-up and debris will continue to block and increase decay of gutters and downpipes.

Figure 6 - Build-up of leaves / debris in verandah eave gutter outside unit 130 note proximity to tree.

Recommendation: installation of leaf guards to gutters near trees and additional overflow spouts to verandah roofs if required. Pruning of trees adjacent to gutters where possible to reduce overhang of roofs.

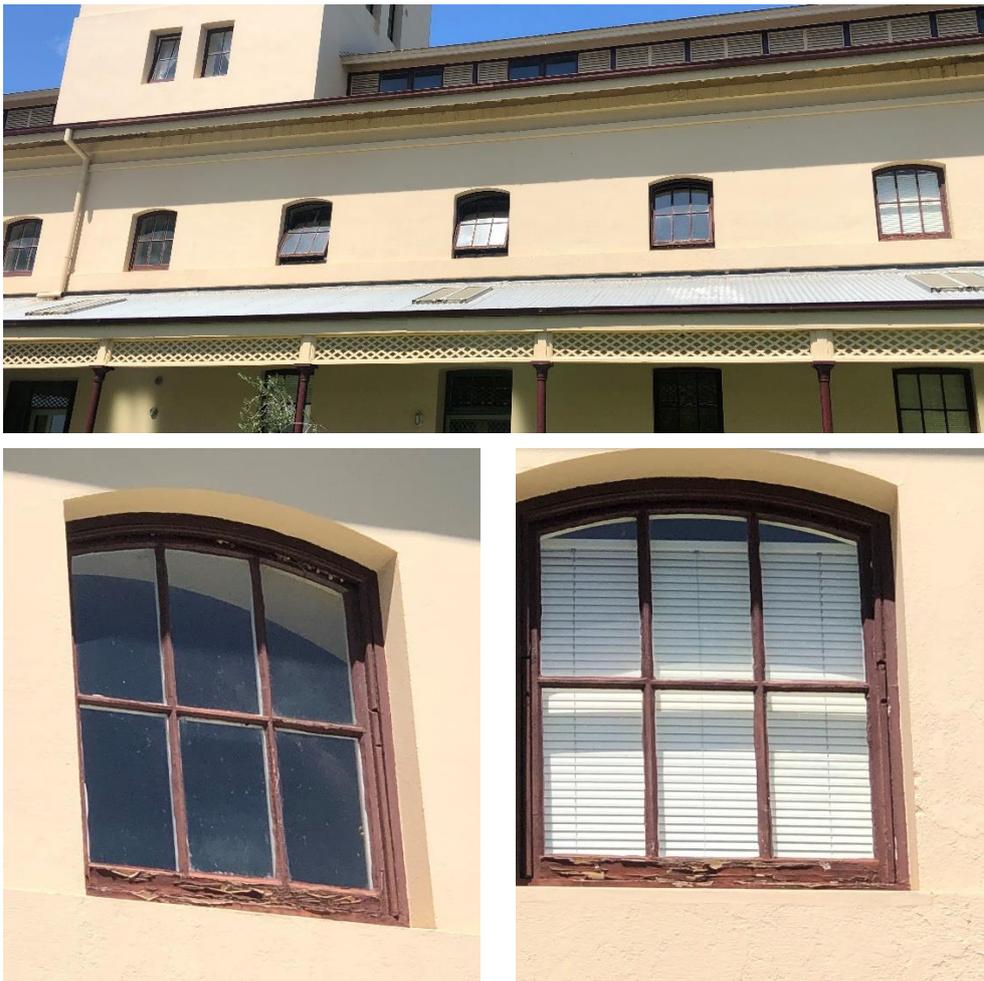
Painted elements throughout are in generally good condition. There are however several west facing first floor windows on the Northeast wing that have substantial paint flaking. While the sills were not observable from ground level it is expected that the sills are in the same if not worse condition and are therefore subject to decay. Some adjacent windows appear to have been painted more recently and are in good condition.

Figure 7 - West facing first floor windows of Units 123-125

Recommendation: A schedule of problem areas should be maintained by the facilities manager to record areas reported to need attention. Individual owners to be consulted with to advise if serious decay has spread internally.
