INSPECTION REPORT

WILLSMERE

Inspection Report – June, 2018

MICM Property — 178 City Rd, Southbank, VIC 3006

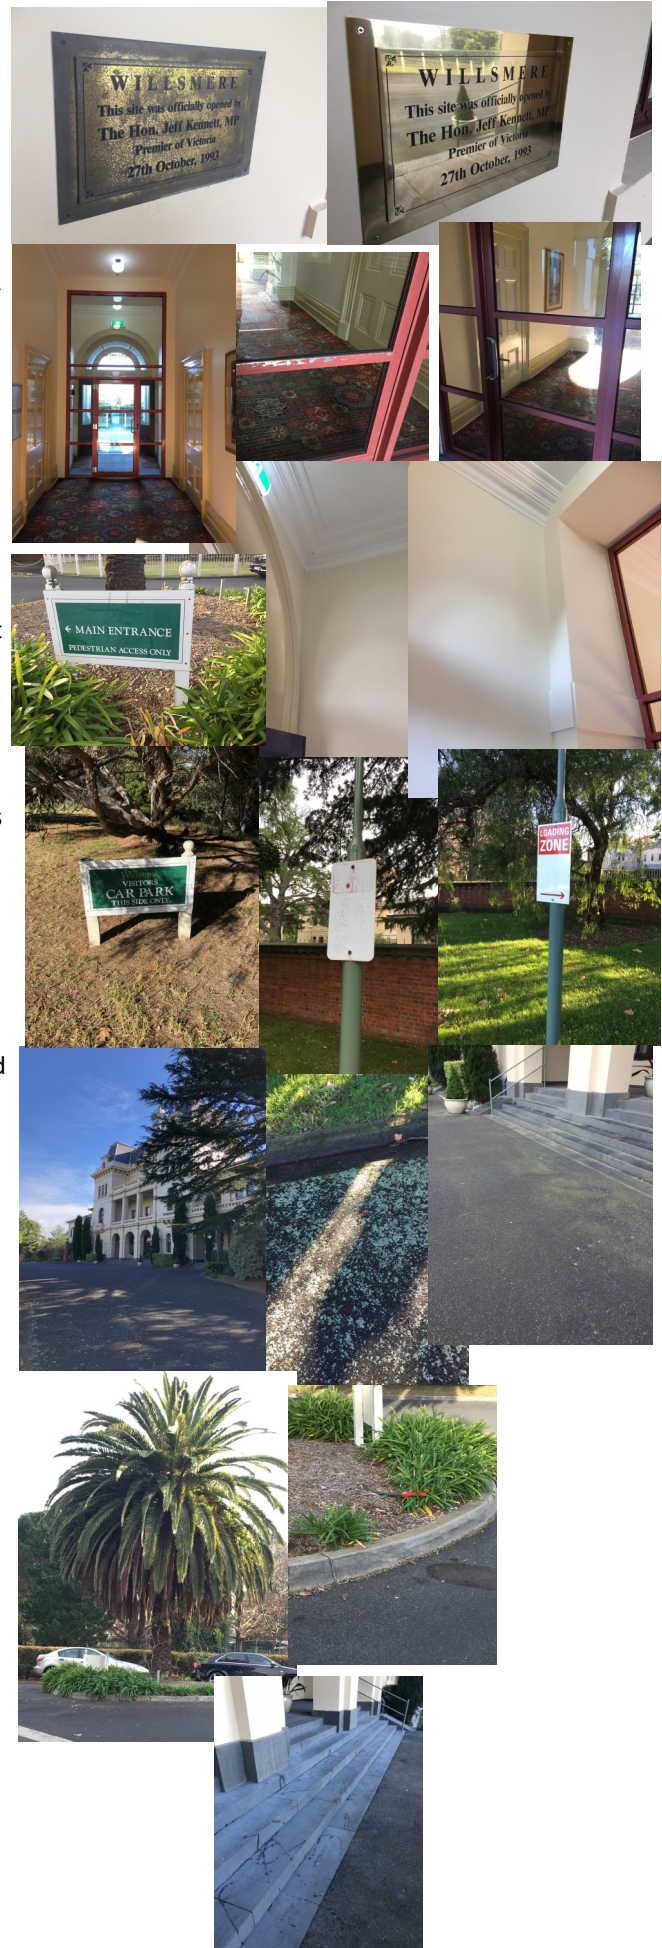
General appearance—Front of the building

Entrance appearance was noted in poor condition.

The Willsmere sign was cleaned and repaired and now looks much better. The front foyer has been painted and is in good state of repair. The paintings have been removed and under the wall has been repaired and painted awaiting the committees decision on the photo competition.

The signage in the car park has been replaced but a requirement for the other Willsmere signs in the garden bed and along the right hand side of the driveway is in need of improvement.

Poles at the fencing have been damaged by the wiper snipping of the grass and could be painted to improve standards.

Pressure washing of the driveway to remove the moss growing has been completed which reduces the risk of the a slipping hazard. Pathed areas near the fountain have been cleaned and paths through the complex is in need of being done.

Garden works are required at the roundabouts in the entrance of the building. Planting and the black mulch would make this area look inviting. The two large palms are in need of major pruning and dead leaves need to be removed.

Damaged bluestone—Reported to Focused due to the Facility manager using chemicals to clean the bluestone. Painting solution was applied to the bluestone which has caused further issues.

Suggestion of a sign audit for quotes on the replacement of all of the signs in the building. Some gate signs are unable to be seen while in the car.

Replanting to the front entrance roundabouts—Quotes to be submitted to the committee for approval.

Repainting of fences and poles maybe required in the future.

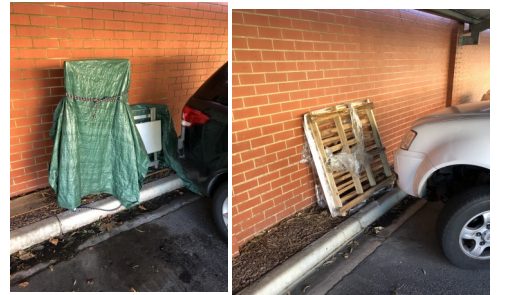
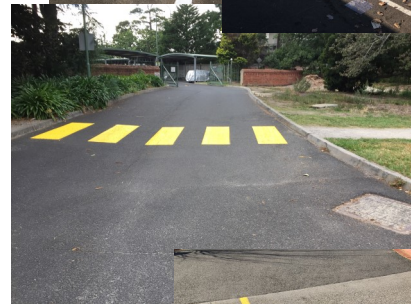
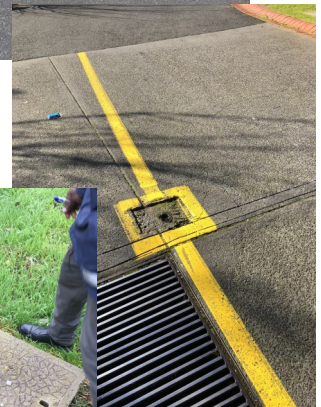
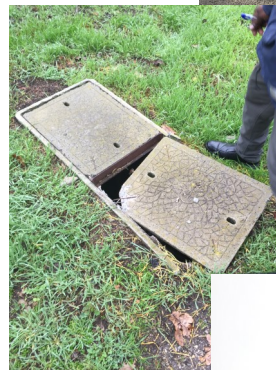
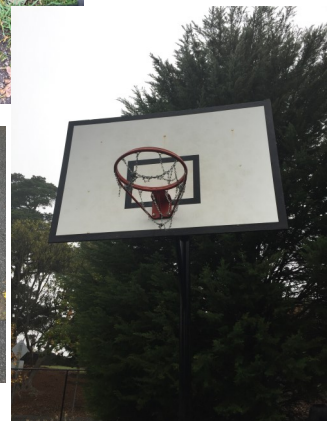
Car park - Overall condition

Car park gates continue to be an issue.

Some areas of the car park have weeds growing from the guttering and a work order will be sent for the gutters to be cleaned. MICM have notified the gardening company to remove the weeds.

A large Telecommunications pit has been damaged. A further issue with the pit is that we have a high potential that the pit is made from asbestos.

Basketball chain—Requires repair and or replacement. Facility manager to investigate and arrange repair.

Asphalt repair is required near drains—Safety concern as cars could be damaged due to these areas. In addition it may be a potential trip hazard.

While working through the issue MICM property discovered that a maintenance agreement on servicing of the gates was not in place. This may reduce the breakdowns and would assist with finding some issues before they cause a problem. Quotes will be presented to the committee. Further understanding of the gates electronic bolts that have been removed or damaged to hold the gates in place have been quoted and will be presented to the committee.

Joel has marked off the area and further investigation is required before we can have this repaired.

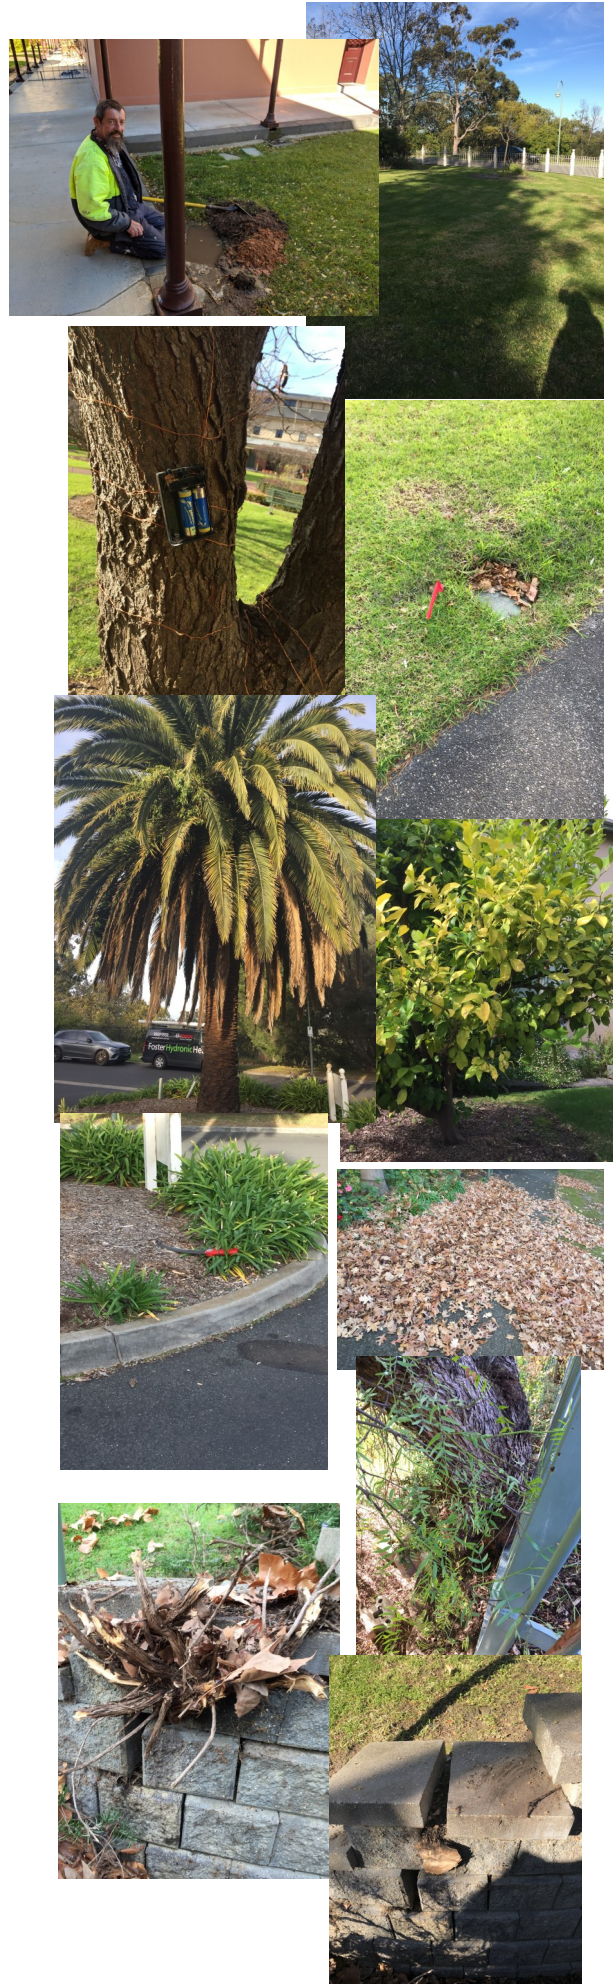
Common Gardens

Common gardens within Willsmere Apartments are in a reasonable condition however further attention is required.

Irrigation has been started and works are continuing to be finalised. Flags are present around the site where the irrigation has been notified as broken causing a leak. Due to the high numbers of leaks in the irrigation system this is taking longer than expected. Rain sensors have been placed around the building to reduce the water bills. These sensors will turn off the sprinklers if and when the rain is present. Saving on water and saving the grassed areas from bogging.

Lemon trees (Near the pool area—Old guard stations) have a pest (Gall wasps) which impacts on the trees health in addition the yellow leaves show that the plants require fertilisers.—Gardener has noted that once the lemons finish fruiting these will be cut back completely.

Plants damaging retaining walls have been cut back and a quote will be submitted to the committee for the repair.

Some plants have grown over the path and require pruning. OCM to review with gardening company and committee.

Some areas have been neglected and require attention eg at gate 4 entrance near the basketball court.

Hedging will require further trimming to bring back the shaping correctly.

Retaining walls are being damaged by overplanting in some areas and needs to be addressed. OCM to obtain further quotes to have this reviewed by the committee.

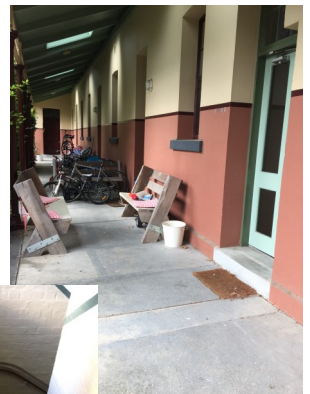
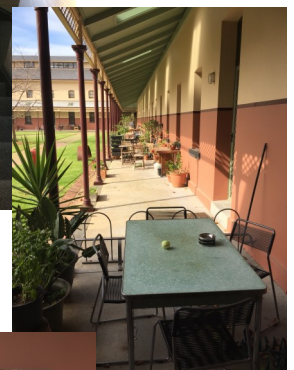
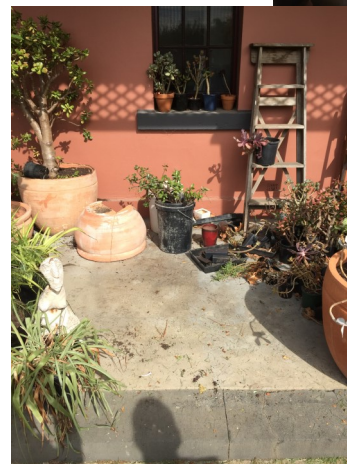
Common Cleanliness of Storerooms, walkways and Common Areas.

Common areas in Willsmere is being used as storage from some residents and common walkways was reported as a potential safety risk in the case of an emergency.

Further concerns on access for Ambulance in cases of emergency evacuation with trollies holding patients, also concerns on fire emergencies have been reported.

Areas used for storing of goods may provide Occupational Health & Safety risk and should be cleaned out.

Checks and walkthroughs with the committee is suggested.

An audit will need to occur and breach notices issued.

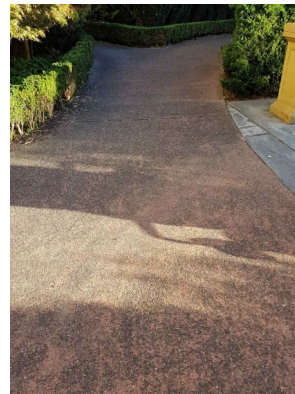
Before

- Cleaning of the pathway around the fountain has been completed and has shown a huge improvement.
- Gutters on the function room/gym have been cleaned due to the large amount of debris found.

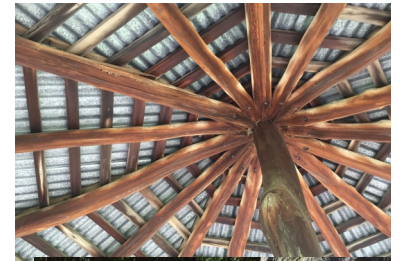
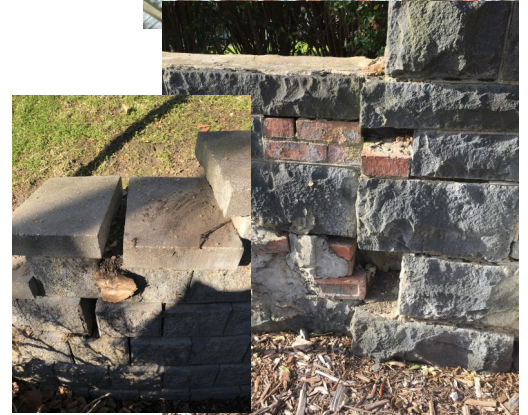
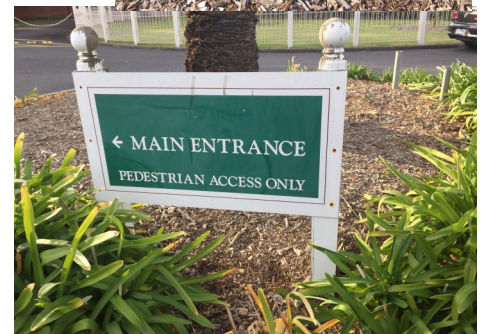
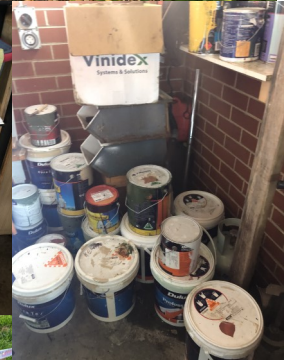
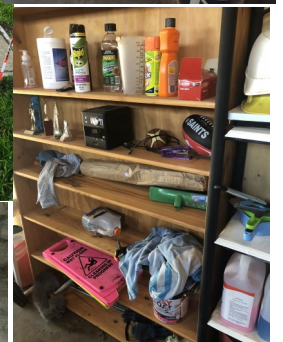
General Repairs and maintenance

Termite damage visible in the hut. Inspection arranged and ordered. Results to be presented to the committee.

Trip hazards have been identified and should be addressed ASAP. OCM and Building Manager to arrange quotes to present to the committee.

Pool area will require full investigation and I believe that members of the committee have noted this area as an area in need of repair. Concrete cancer is evident in the pool flooring and reports to be reviewed. OCM and Building manager to report and confirm with the committee on further details.

Cleaning chemicals not stored correctly by the Facility Manager paint tins old and new stored in facility managers shed.

Removal of graffiti in the dungeon. Committee to inform the OCM on further instructions.

A detailed inspection and report of all minor repairs to be undertaken and further walkthroughs with the committee and building manager required.

MICM notified the Facility manager to keep the doors closed at all times due to a risk of theft and hazards.
